This program will address the most common system problems associated with the A&E Patio Awnings supplied by The Dometic Corporation. Our intent is to provide you with a guideline of checks to make, should you encounter one of the following symptoms.

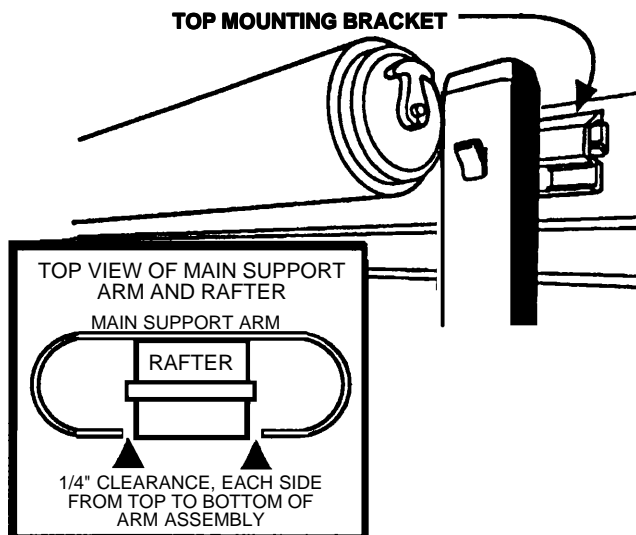
1.5 TOP MOUNTING BRACKETS

The top mounting bracket supports the main rafter assembly to hold the awning in the open extended position, and allows the rafter to pivot into the "C" channel of the main support arm. Each top mounting bracket should be mounted directly over the awning rail so the screws go through the "C" portion of the rail.

On the Series 9000 awning the top mounting bracket can be mounted lower when possible. If the top mounting bracket is mounted above center of the awning rail, the aluminum guard may not cover the fabric completely in the closed position. If this is the case, relocate the top mounting bracket accordingly.

The top mounting brackets have slotted holes for the mounting screws, allowing them to be adjusted side to side. To adjust the brackets, close the awning and sight down the main support arm and the main rafter. The clearance on each side of the rafter should be approximately 1/4 inch. If clearance is not appropriate, adjust the top mounting bracket(s) as necessary.

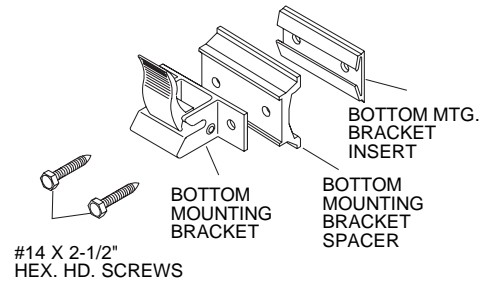
1.6 BOTTOM MOUNTING BRACKETS

The bottom mounting brackets are screwed to the floor line of the unit, and they support the weight of the awning. They also provide a quick release to set up the awning in the patio position.

If a bottom mounting bracket settles, sags, or becomes loose it can reduce the clearance between the top casting of the torsion and the extension of the top mounting bracket, making operation difficult.

Check the bottom mounting bracket for looseness or settling, and tighten or reposition it accordingly for proper operation.

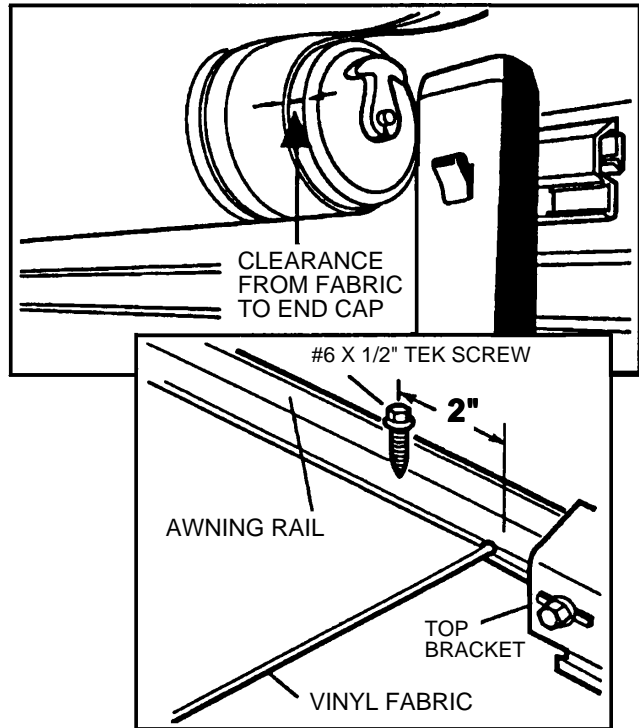
2.1 POSITION

For the awning to operate properly the fabric must be positioned properly in the awning rail and on the roller tube. Open the awning and check the position of the fabric between the top mounting brackets. If the fabric is not centered, remove the tek screws, center it, and replace the screws.

When the fabric is properly positioned, next check the position of the fabric on the roller tube. The clearance from the end cap of the torsion assembly to the edge of the fabric must be the same on each end. If it is not, adjust the fabric on the tube as necessary. On the Elite 9000 and 9500 awning the fabric is held in place to the weatherguard with 1/8" pop rivets. Check the position of the fabric at each end of the weatherguard. If the fabric has shifted, remove the pop rivets, center the fabric and re-rivet.

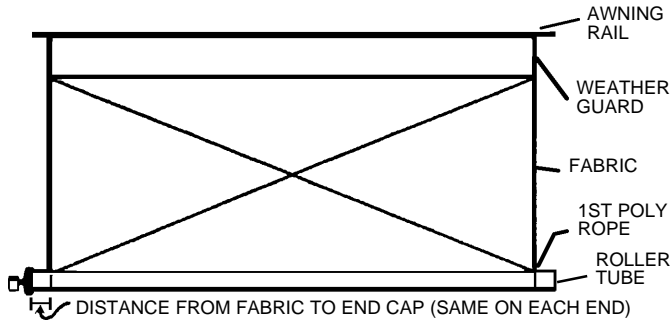
2.2 SQUARE

To check fabric for square, measure from the top right hand corner of the fabric (not the weatherguard) to the bottom left hand corner at the poly rope. Now measure from the top left hand corner to the bottom right hand corner as shown below.

In this check, the difference of the two dimensions should be no more than one inch. If it is more, the fabric is out of square, and replacement would be necessary.

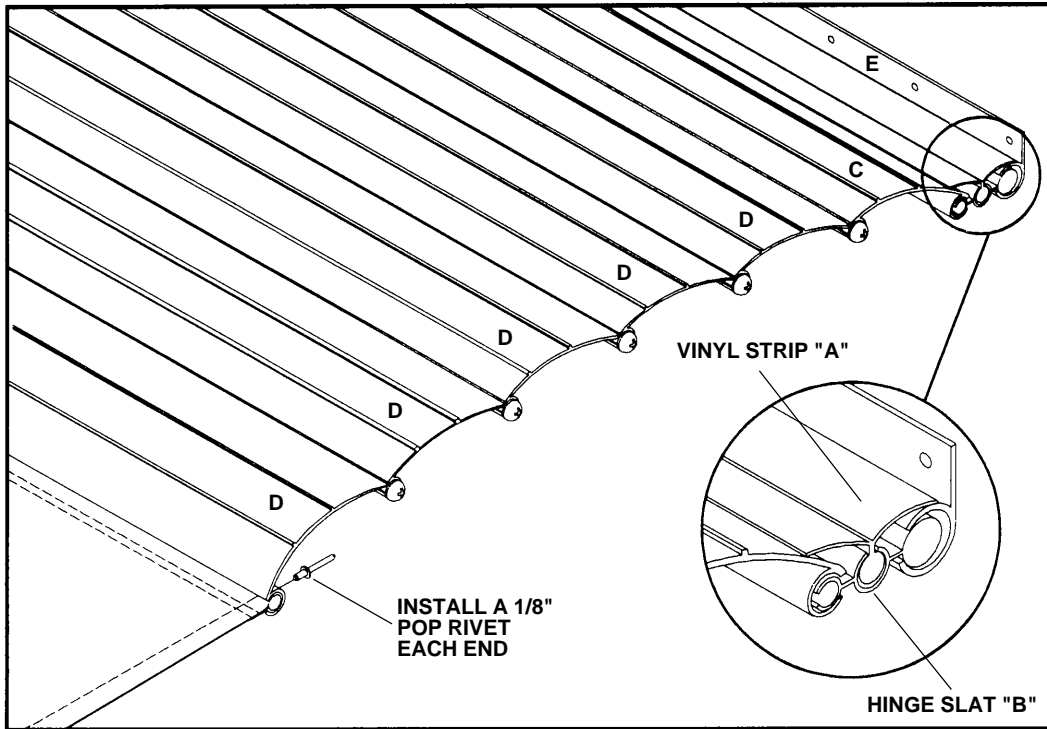
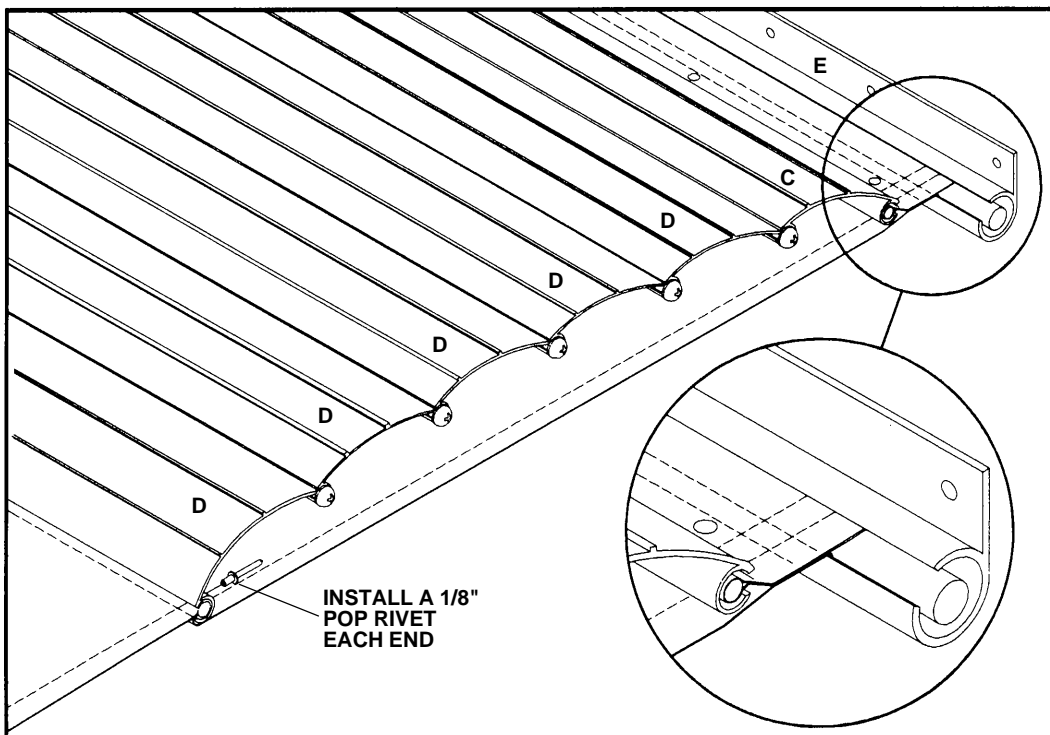
9000 WITH HINGE SLAT

- A - VINYL STRIP**
- B - HINGE SLAT**
- C - TOP SLAT**
- D - MAIN SLAT**
- E - AWNING RAIL**

TOP SLAT "C"
VIEW RH END

MAIN SLAT "D"
VIEW RH END

HINGE SLAT "B"

VINYL STRIP "A"
